Ball bearing change on new first 211 keel system.

Disassembly

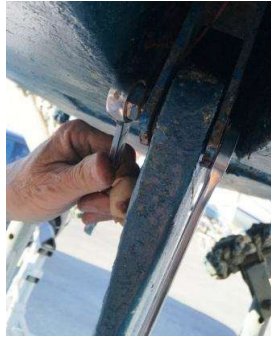
This is done with the keel down. In this position, the fixing of the fork on the keel is accessible. With 2 19mm spanners, the 12x55 stainless steel bolt which secures the fork to the keel is removed. Once this bottom bolt is removed, the system can be removed from above in the cabin. Remove the cord - knot on the fork - and leave it in place. Disembark the lifting system to work properly.

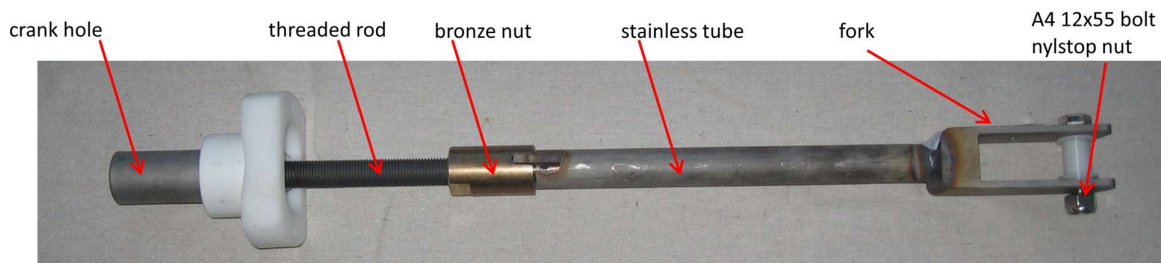
The lower stainless steel tube has a welded lug that locks the bronze nut.

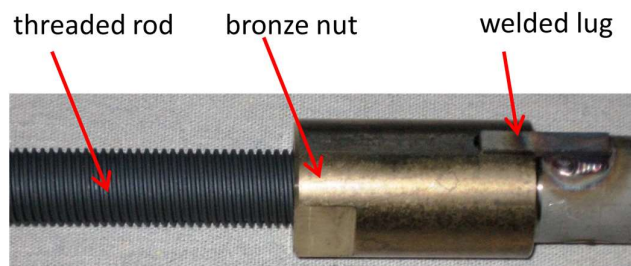
This lug is gently twisted with a screwdriver to be able to unscrew the bronze nut from the stainless steel tube.

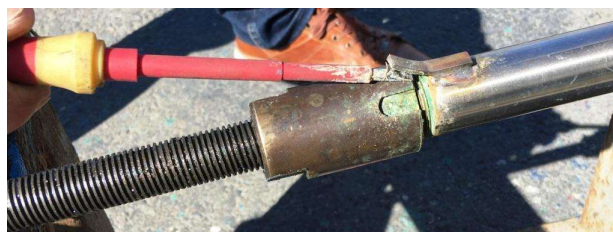
We can then access the bottom of the threaded rod which has a safety device to prevent it from coming out of the nut when the keel is lowered to the maximum and that we unfortunately continue to turn the crank counterclockwise. This security is a nylon washer, two steel washers and a bolt.

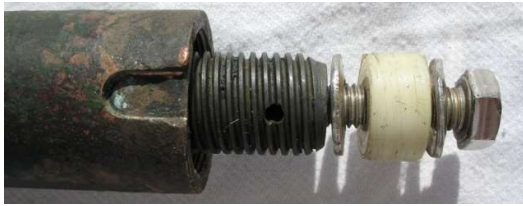
correct system

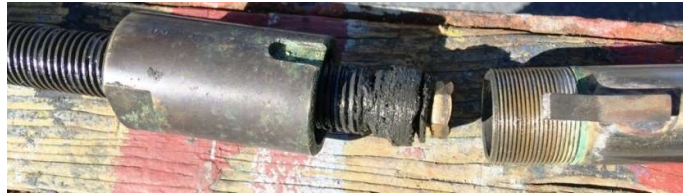
our 5 years old system. There was water in the lower tube

After 5 seasons, our lower tube contains water. This seized the safety bolt at the bottom of the threaded rod We should have checked this at each fairing. In addition to cleaning the hull and applying antifouling, the keel maneuvering system should be removed to be cleaned and lubricated each season.

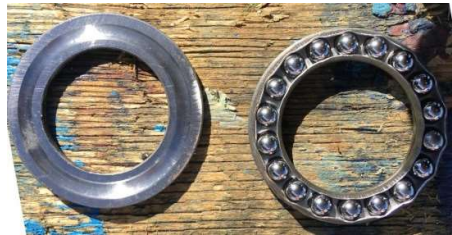
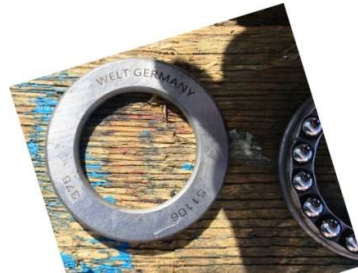
Once this security has been removed, you can finally unscrew the nut of the threaded rod to disassemble the nylon rings and put the new ball bearing in place.

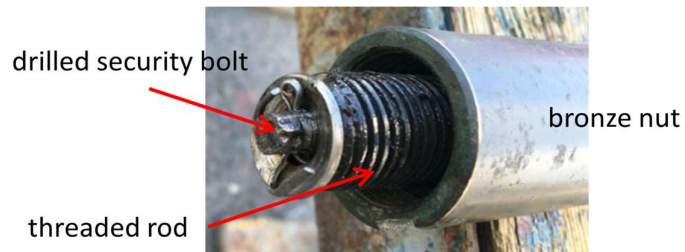
Our security bolt broke when we tried to remove it from the threaded rod and we couldn't get it out. We therefore drilled it (2.5mm) in order to put a pin behind a stop washer.

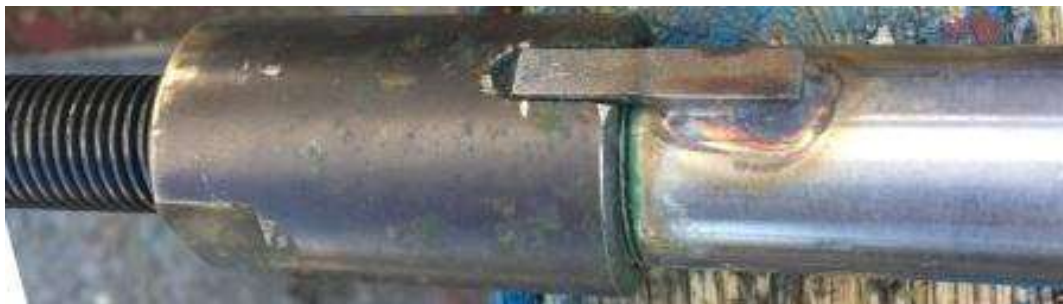
We put the twisted lug back in place in the notch of the screwed nut on the stainless steel tube. This lug has not broken... To be checked later...
